Third edition

Repair, Protection and Waterproofing of Concrete Structures

P. H. Perkins

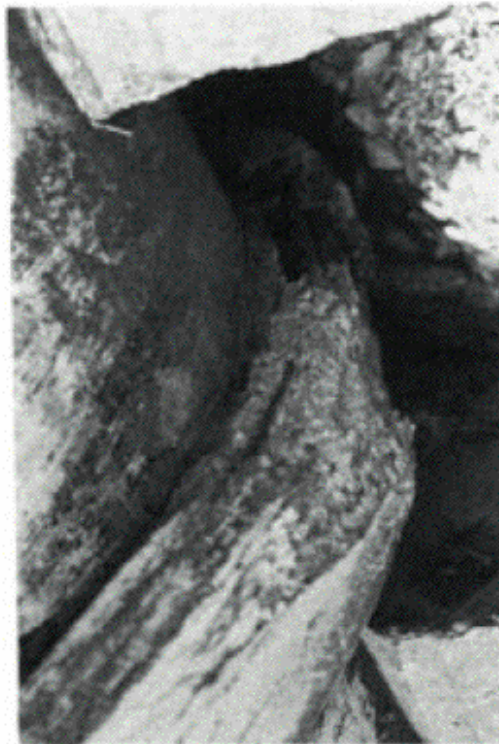
Figure 3.1 Frost damage to large-diameter concrete pipe laid above ground in the Scottish Highlands.

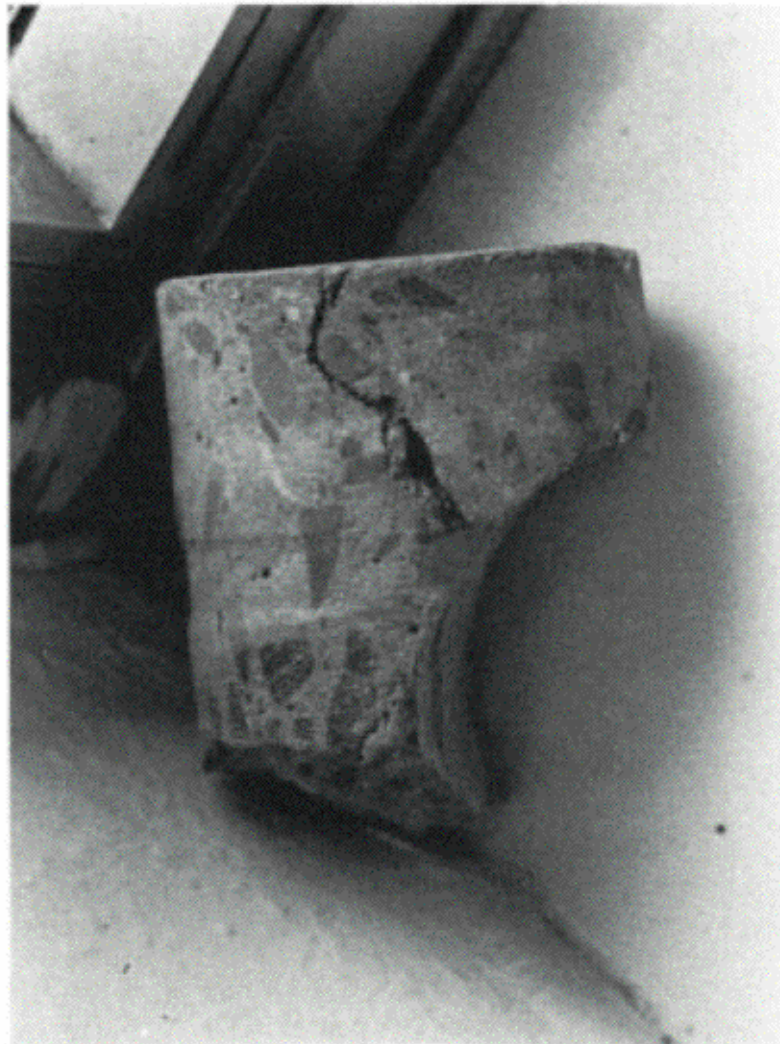
Figure 4.3 Plastic settlement cracking near the head of a mushroom-headed column.

1. plastic cracking (see Figure 4.2);
2. plastic settlement cracking (see Figure 4.3);
3. cracking caused by corrosion of reinforcement (see Figures 4.4 and 4.5);
4. drying shrinkage cracking;
5. thermal contraction cracking (see Figure 8.3);
6. map pattern cracking (crazing);
7. cracking due to bad workmanship (see Figure 4.6);
8. cracking caused by alkali-silica reaction;
9. flexural cracking.

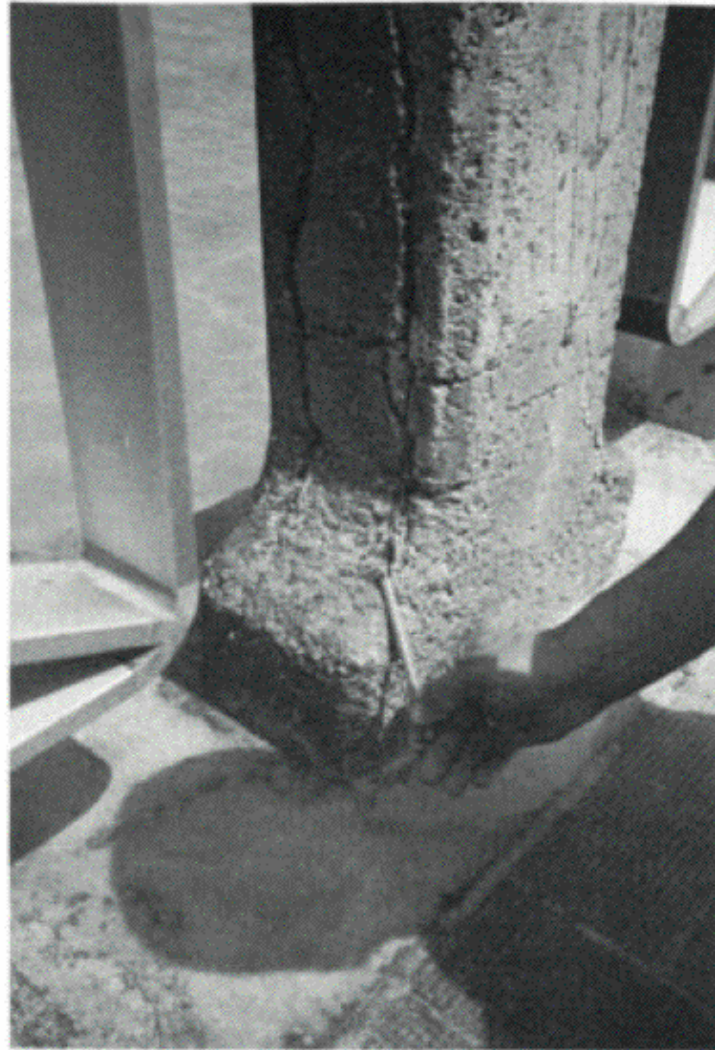
Figure 4.4 Cracking and spalling in concrete column due to rebar corrosion caused by chloride-contaminated aggregates. Courtesy, A/S SCancem, Norway.

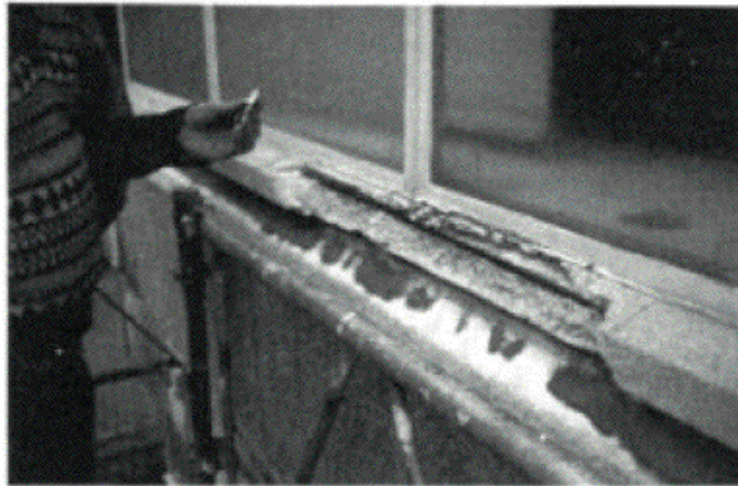
Figure 4.5 Damage to precast concrete sills caused by rebar corrosion.

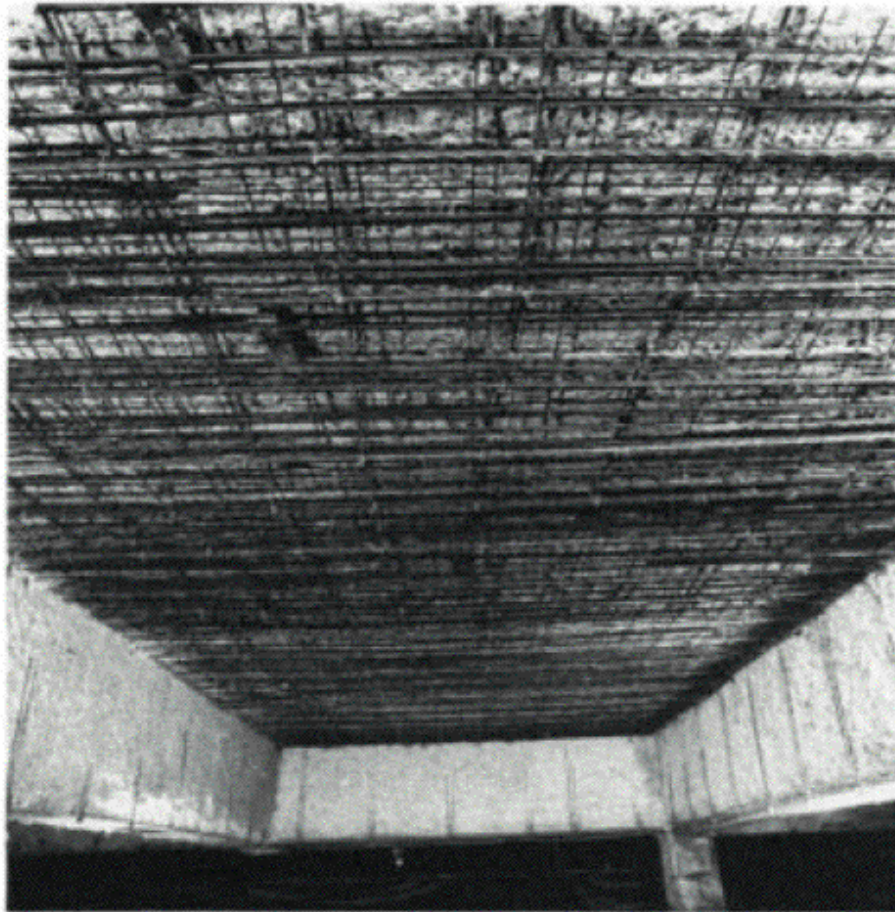
Figure 6.4 View of floor soffit in Figure 6.3 after fixing of new reinforcement prior to guniting. Courtesy, Cement Gun Co. UK Ltd.

existing and new, are completely embedded, i.e. the elimination of voids behind the rebars. This work may be a sub-contract to the main contract and it is important to ensure that only special contractors, with considerable experience and a proven record of satisfactory work, are employed. (See Figure 6.4.)

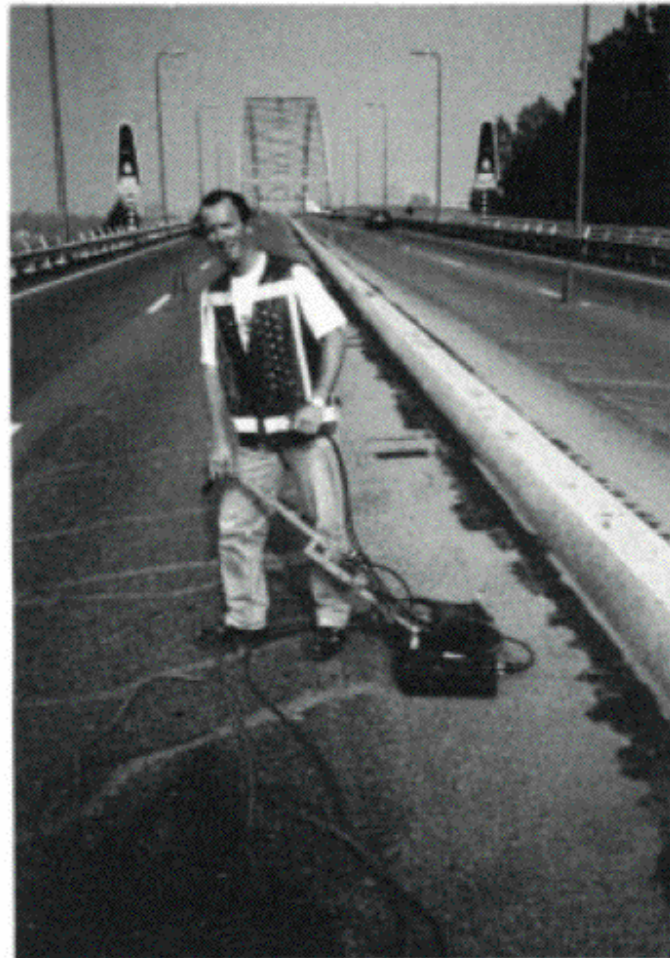
Figure 6.5 Impulse radar survey on Papendrecht Bridge, Netherlands. Courtesy, GB Geotechnics.

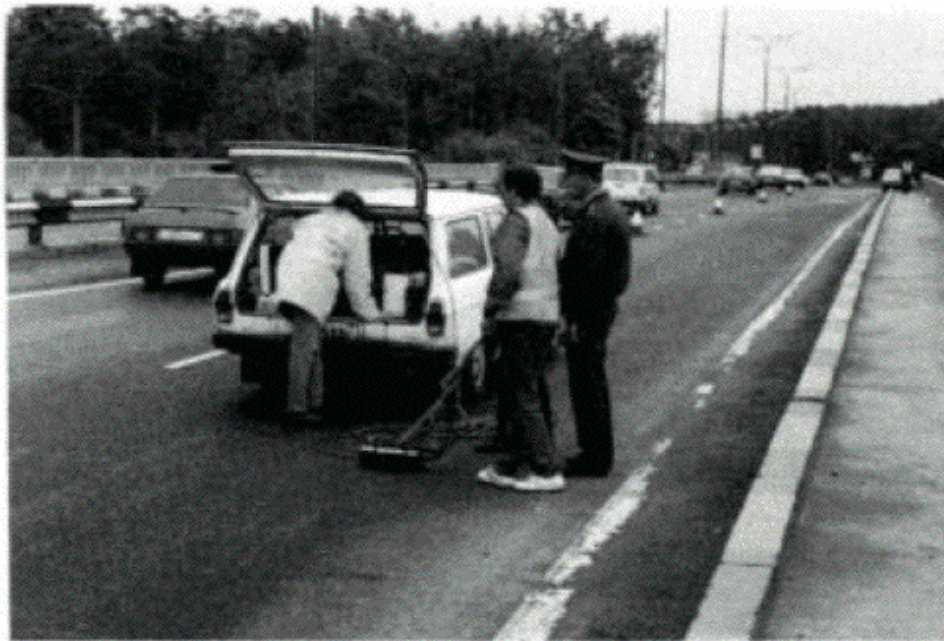
Figure 6.6 Impulse radar survey on Khimkinski Bridge, Moscow. Courtesy, GB Geotechnics.

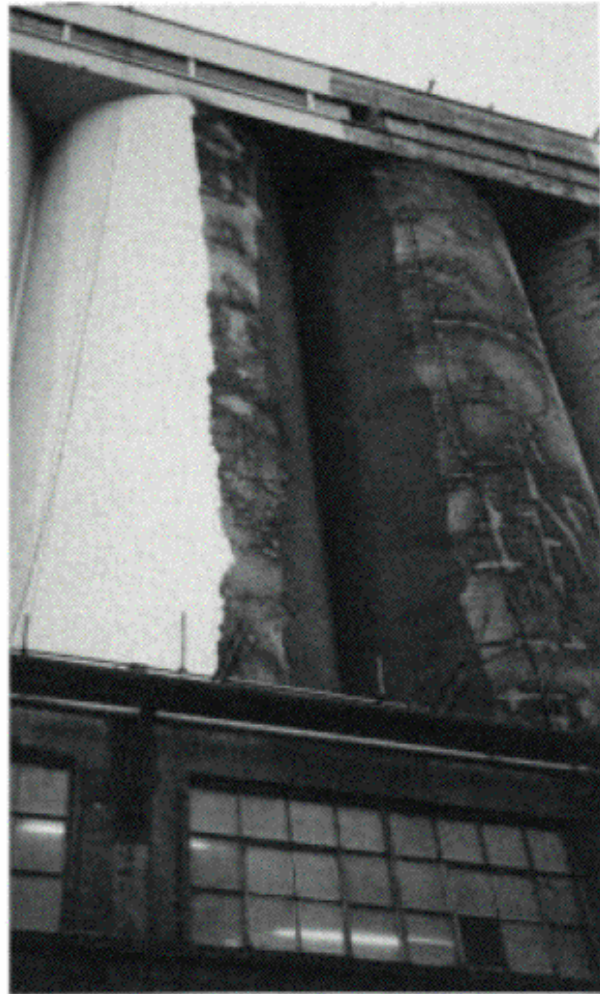
Figure 6.8 Silo in Figure 6.7 under repair showing part of final treatment with three-coat reinforced elastomeric coating. Courtesy, Gunac UK Ltd.

experience is that many of these older structures make a first impression of being fit only for demolition, but a detailed investigation shows that such a drastic solution is not justified. (See Figures 6.7 and 6.8.)

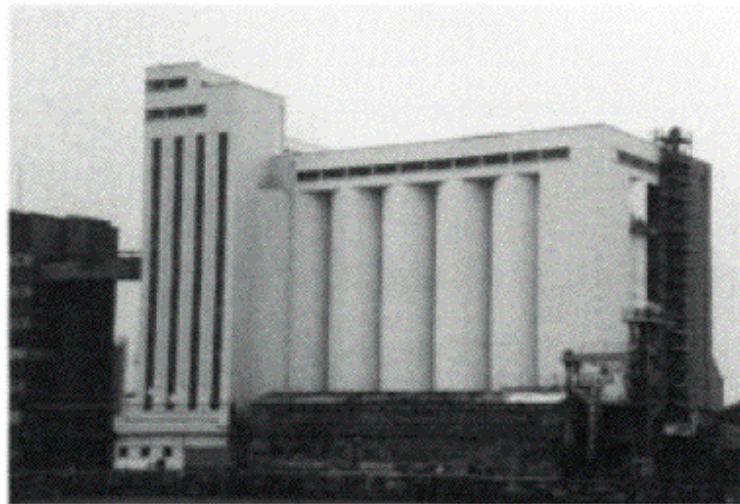
Figure 6.9 View of silos shown in Figures 6.7 and 6.8 after completion of repairs. Courtesy, Gunac UK Ltd.

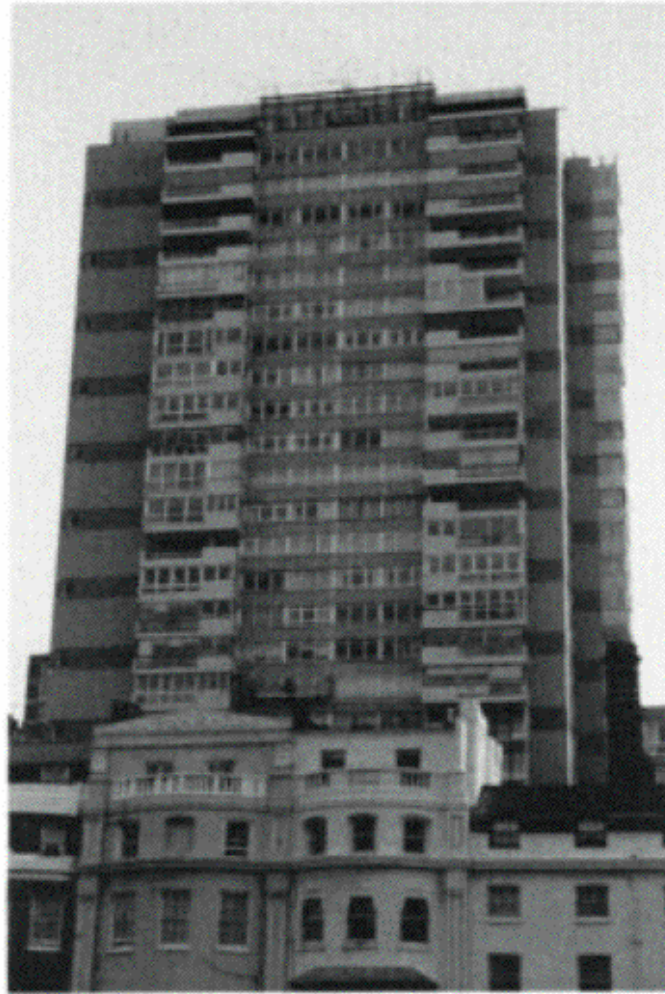
Figure 7.1 View of block of flats with defects in the concrete, and in the cement/sand rendering and in the mosaic finish. Courtesy, Gunac UK Ltd.

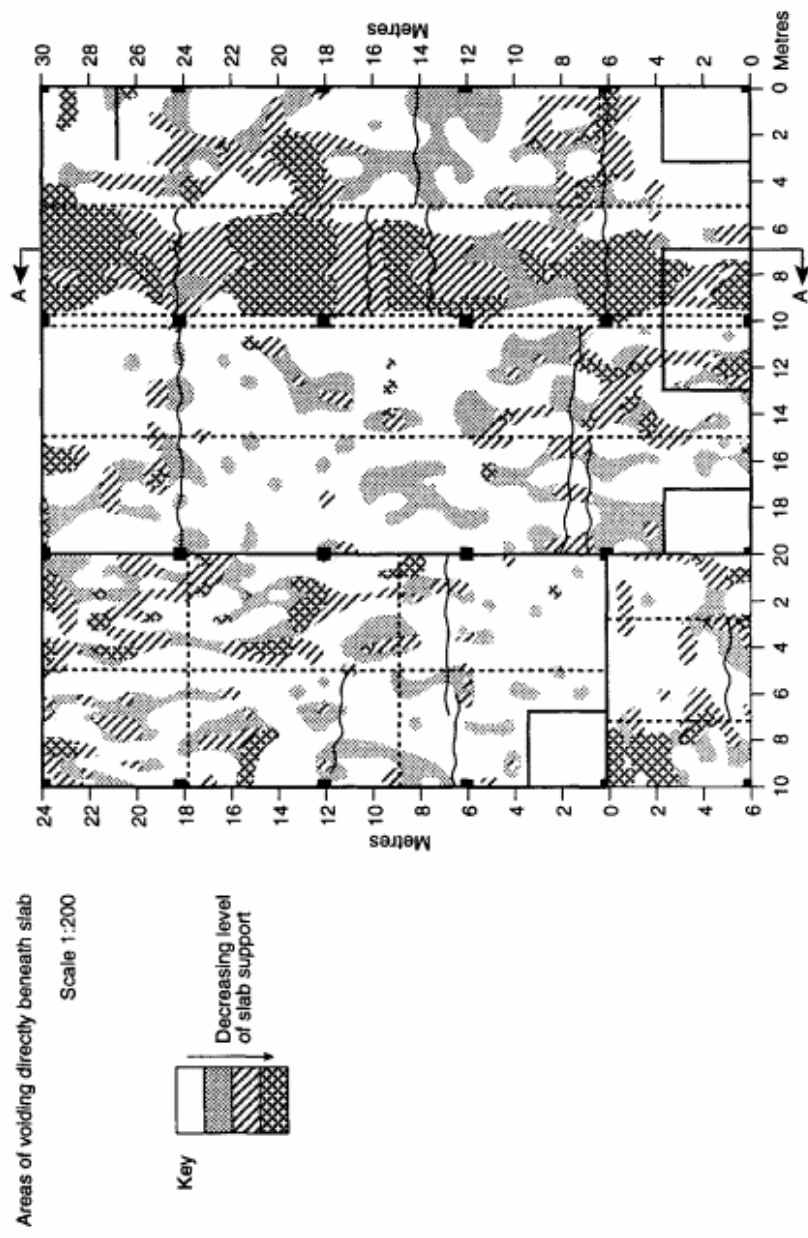
Figure 8.2 Result of investigation by impulse radar, of support to industrial ground floor slab. Courtesy, GB Geotechnics.

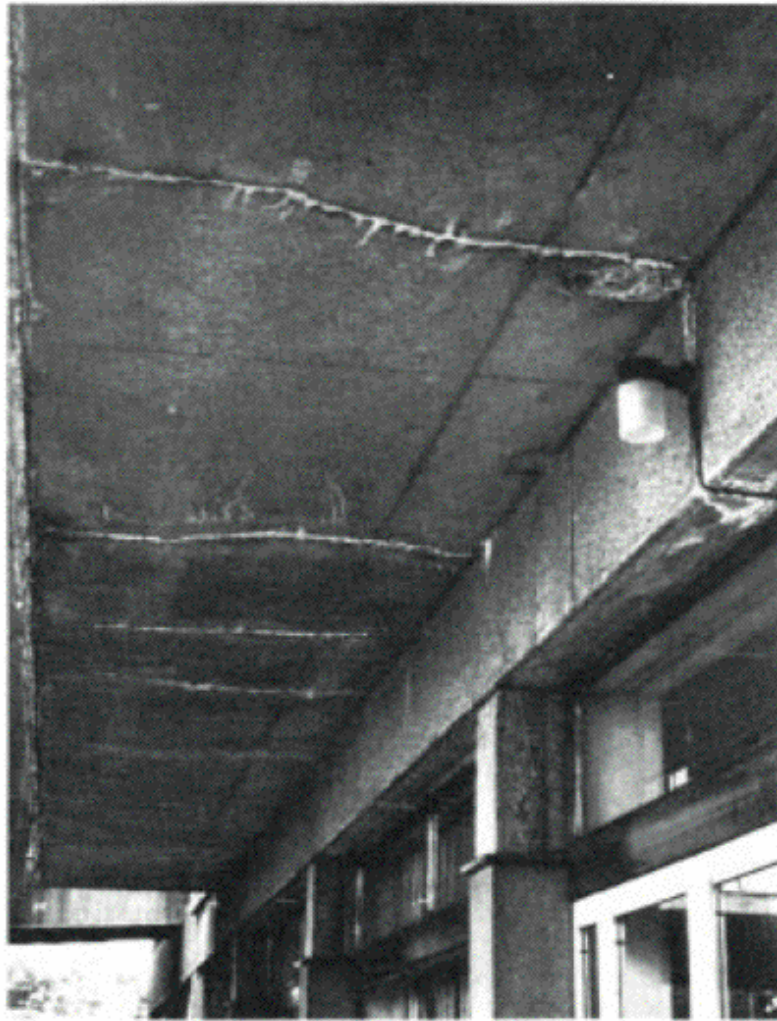
Figure 8.3 View of thermal contraction cracks in soffit of balcony slab. Courtesy, Prof. B.P.Hughes, Birmingham University.

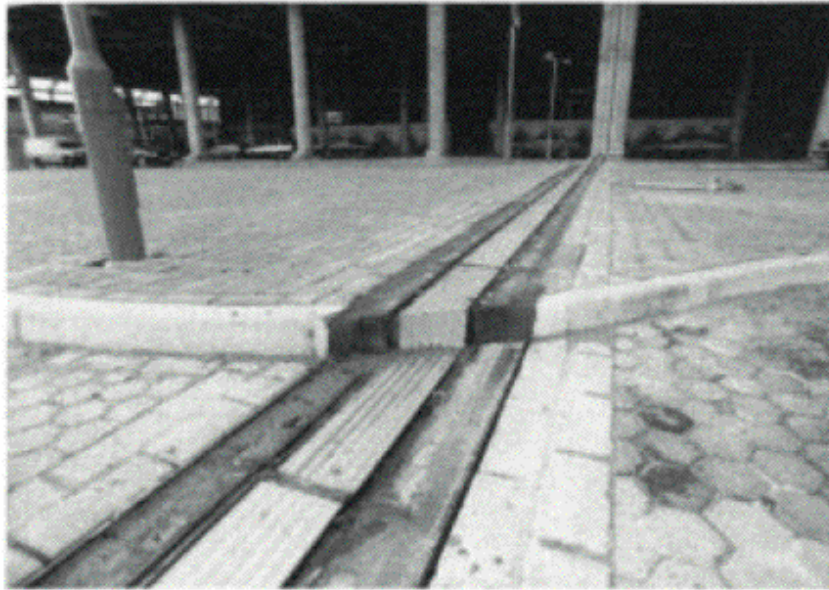
Figure 8.5 Sealed movement joint in floor of car park. Courtesy of Serviced Ltd.

If the joint has been designed 'in-house' then my experience is that serious consideration should be given to its replacement by a proprietary mechanical joint system such as Servicised LM50, or 'Waboflex SR', both marketed by Servicised Ltd. The cost of fitting such a system into an existing floor would be very high. The alternative would be to remake the joints in the 'usual way' and then provide gutters under the joints to catch the seepage which would undoubtedly occur. See Figures 8.4 and 8.5.

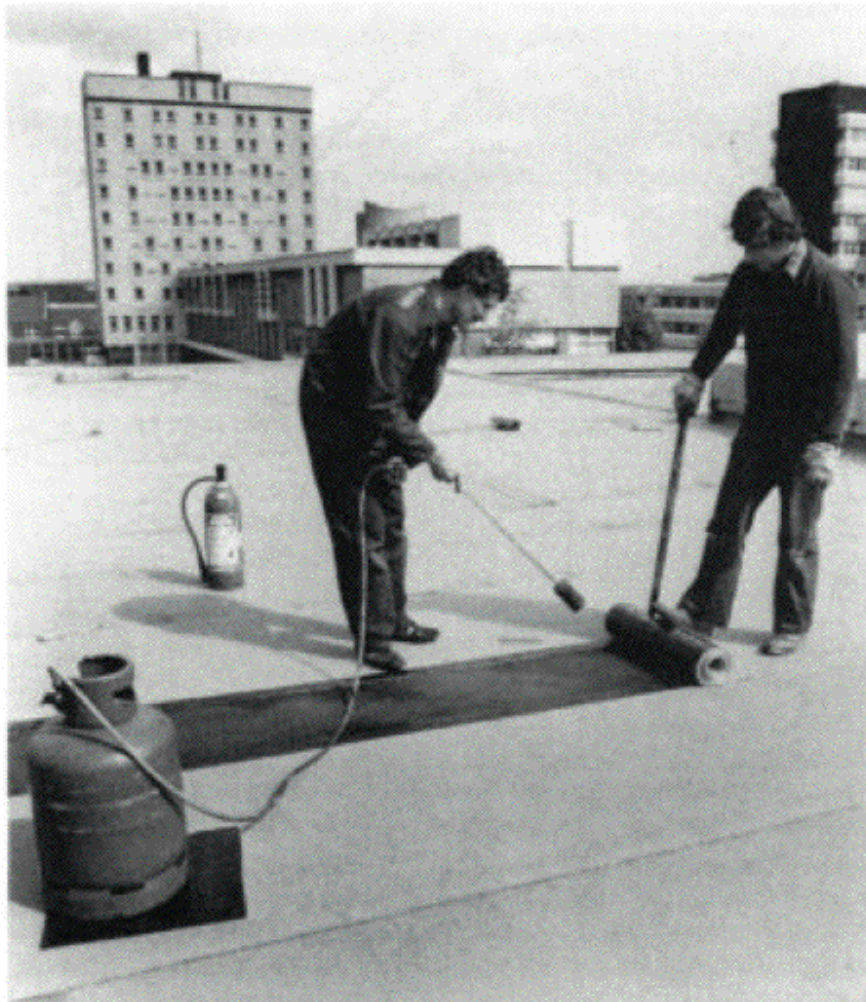
Figure 8.6 'Torch-on' roofing membrane. Courtesy, Ruberoid Ltd.

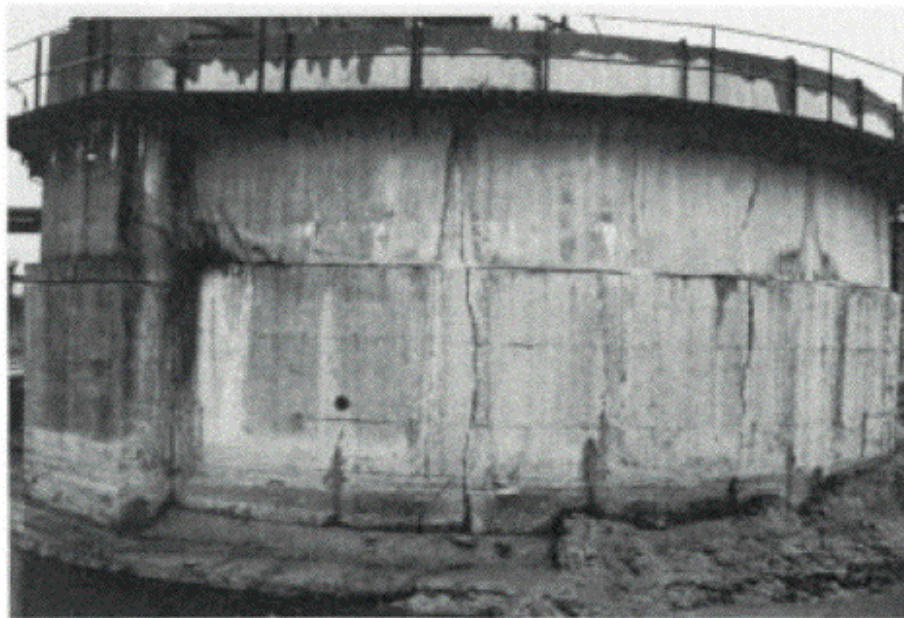
Figure 9.2 Deteriorated concrete slurry tank due to reinforcement corrosion. Courtesy, Cement Gun Co. UK Ltd.

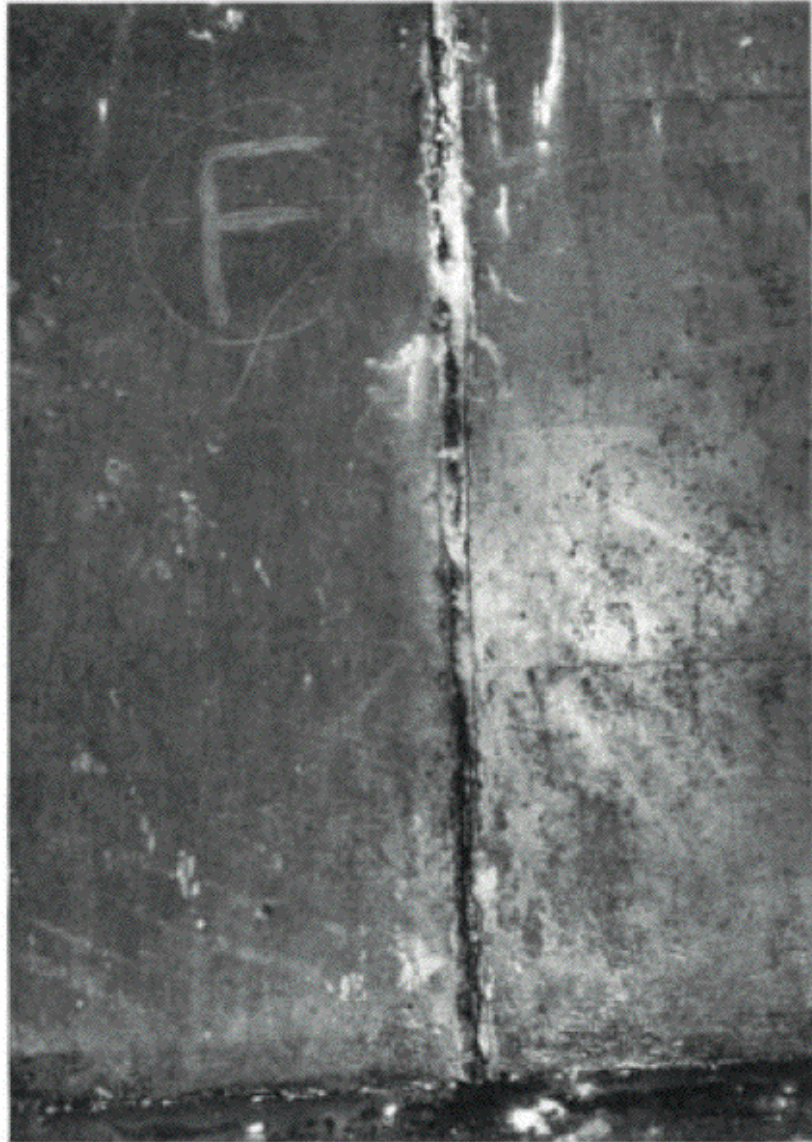
Figure 9.5 Deteriorated sealant in joint in wall of water reservoir. Courtesy, Colebrand Ltd and Thames Water Authority.

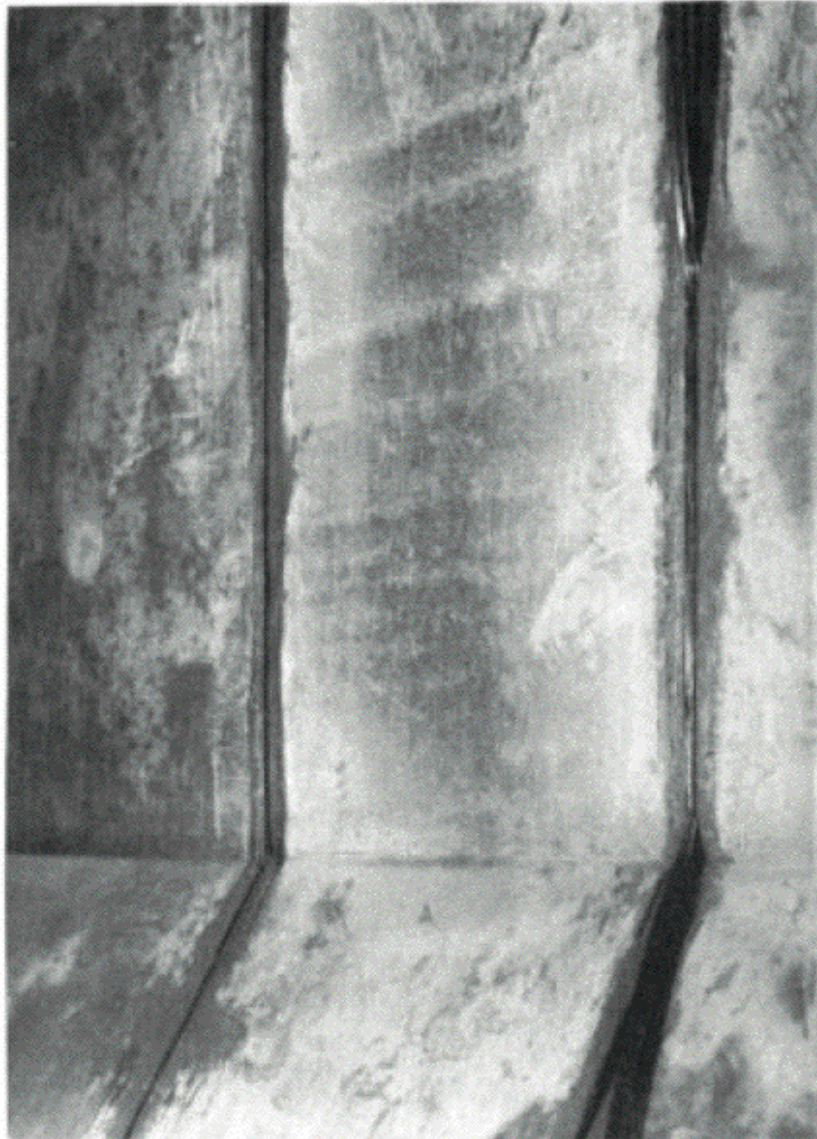
Figure 9.6 Joints in wall of water reservoir being resealed with Neoferma-EPDM gaskets. Courtesy, Colebrand Ltd and Thames Water Authority.

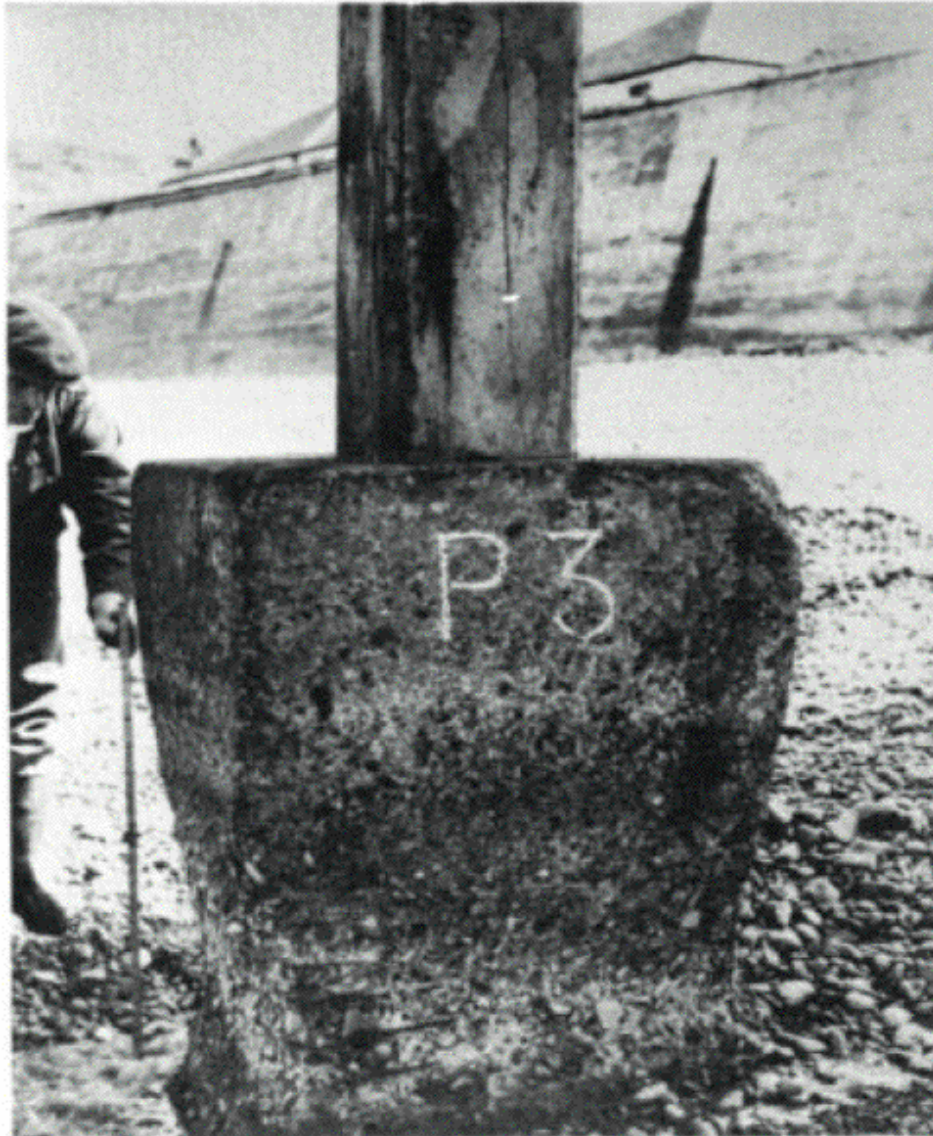
Figure 9.9 View of abrasion of concrete pier by shingle and sand.
